BROTHER Standard Gauge RIBBERS

The Brother KR830 and KR850 are almost identical. The major difference is in the carriages, but they are interchangeable between the two ribbers.

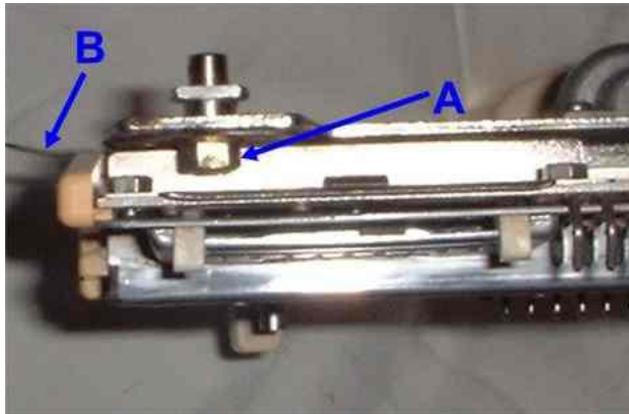
Height is the commonest problem. Set the ribber at H5 and draw out a few main bed needles at each end. There should be a small gap between the needles and the sinker posts of the ribber. Brother's recommendation is just over 1mm. That is about the thickness of a c.d.

To alter height, lower the ribber and use the spanner provided with the ribber or an 8mm open ended spanner to loosen nut 'A'. Lift the ribber into normal working position. The lever 'B' can then be moved to change the height of the bed relative to the brackets. Check on both ends of the bed that you can just pass a c.d. between the needles and the ribber sinker posts. I usually tighten the nut from the side, not moving the ribber until it is fixed. The nut needs to be secure, but excessive force is not required to hold it.

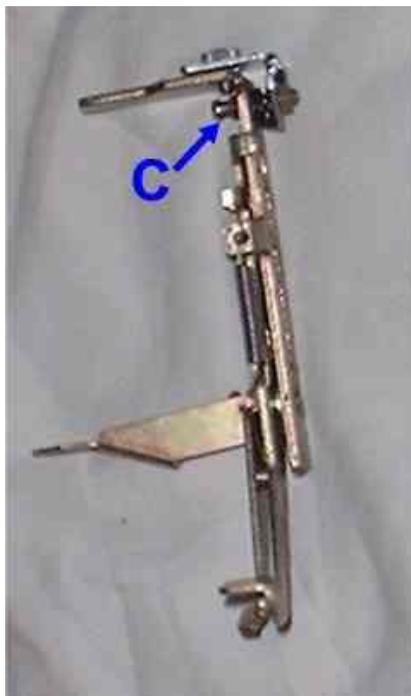
The needles of both beds should align perfectly when the ribber is set to P5. There is a small amount of play in the fixings, so during setup you can check that the needles are 'nose to nose' before tightening the screws and clamps. If you find that there is more adjustment required there are two screws on the front of the ribber, just below the racking number indicator. When these are loosened the racking mechanism can be moved relative to the machine bed by moving the handle slightly. When tightening the screws do not use excessive force.
